4 Loader Lane and 2 Ararat Lane, Clifton, Christchurch

Geotechnical Report for Resource Consent

Project 51274 - Rev 0 - 02/08/2023

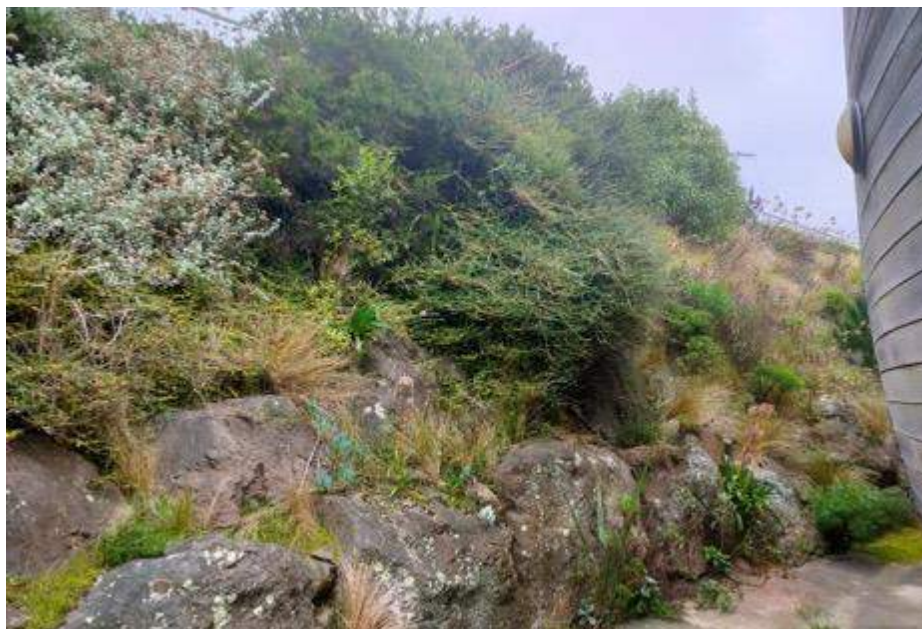
Figure 8: Example of the mass wall between Lot 4 (Lower elevation) and Lot 5 (higher elevation), looking west (Area 1)

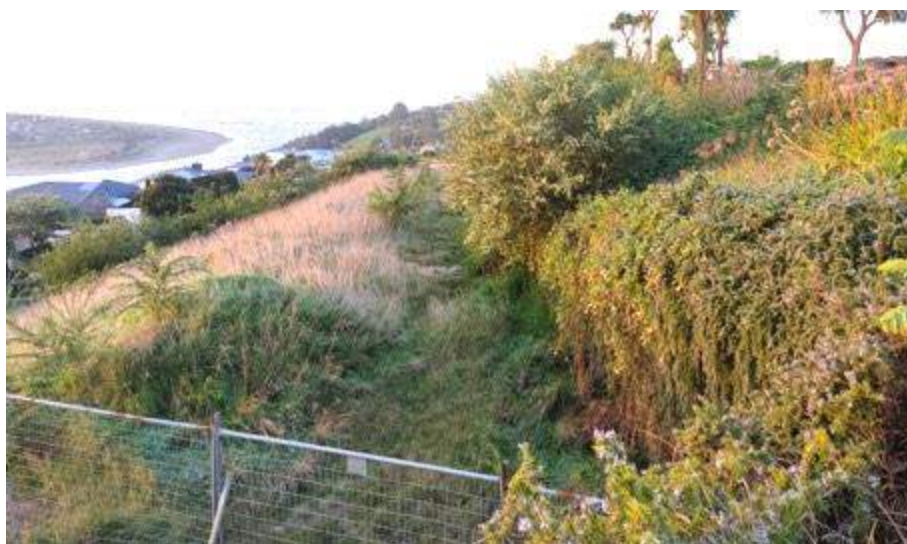
Figure 11: View of the retaining wall west of Lot 7, looking northeast (Area 1)

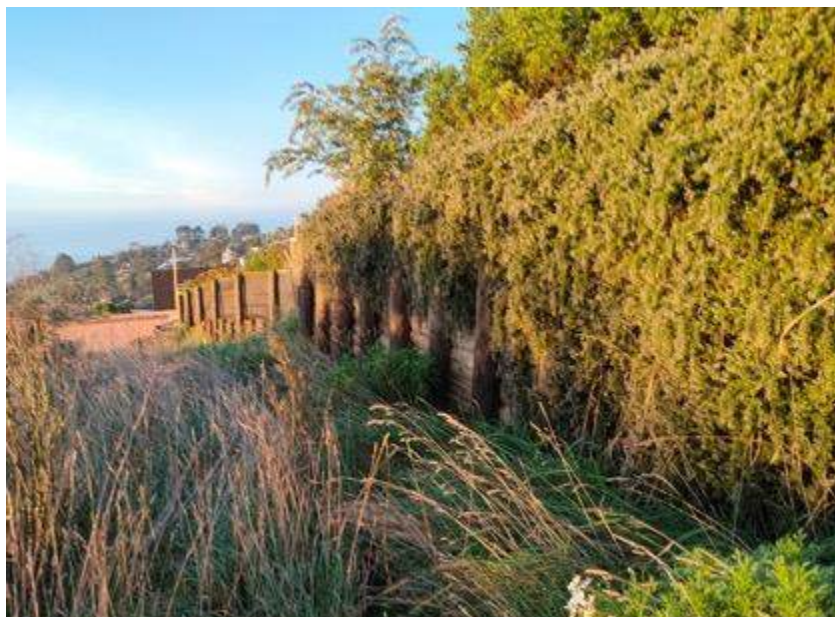
Figure 12: View of the retaining wall below Lot 7, looking northeast (Area 1)

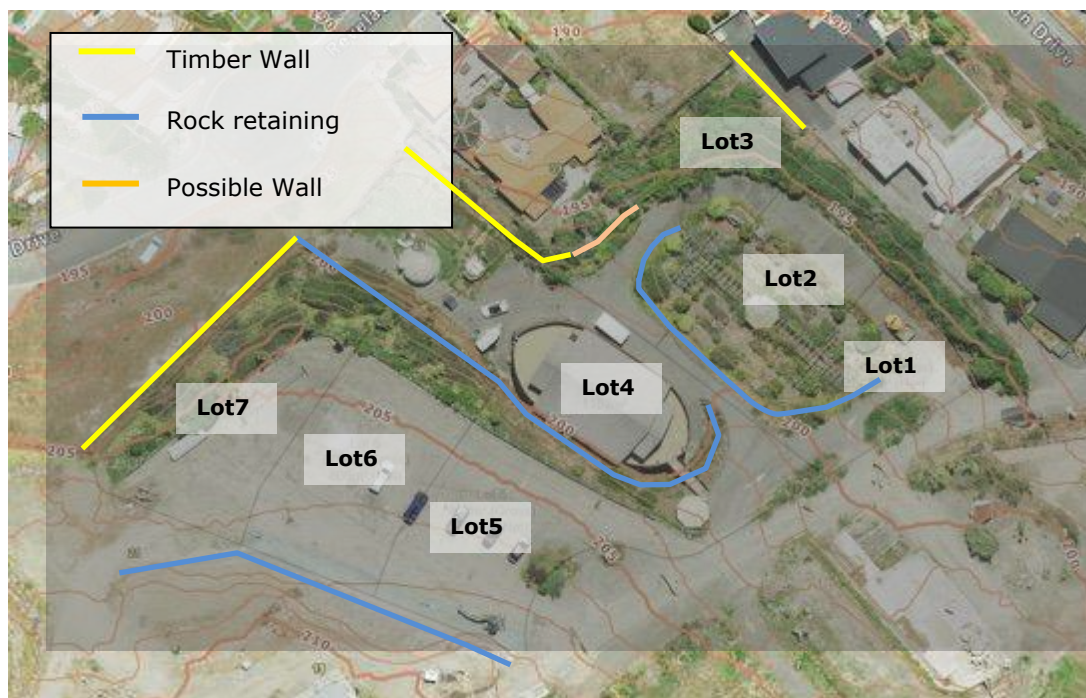
Figure 13: Location of retaining wall structures

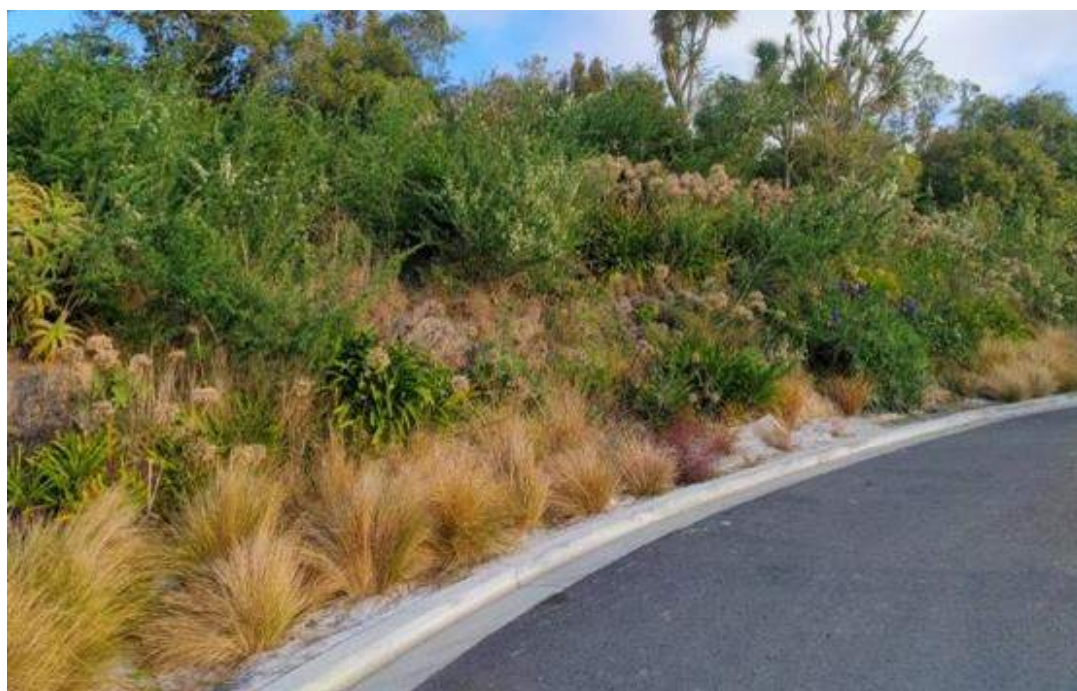
Area 2 is accessed via a right of way off Ararat Lane, the area forms a ridge that is generally sloping to the northwest, with the land to the south sloping to the southeast. The grounds are vegetated, with tall grasses and mature trees along the northern boundary. Along the northern and eastern boundary, the site slopes approximately 20-25° (Figure 19). No retaining walls were observed.

Figure 19: View from Ascott Road, looking towards Lots 9 and 11 (Area 2)

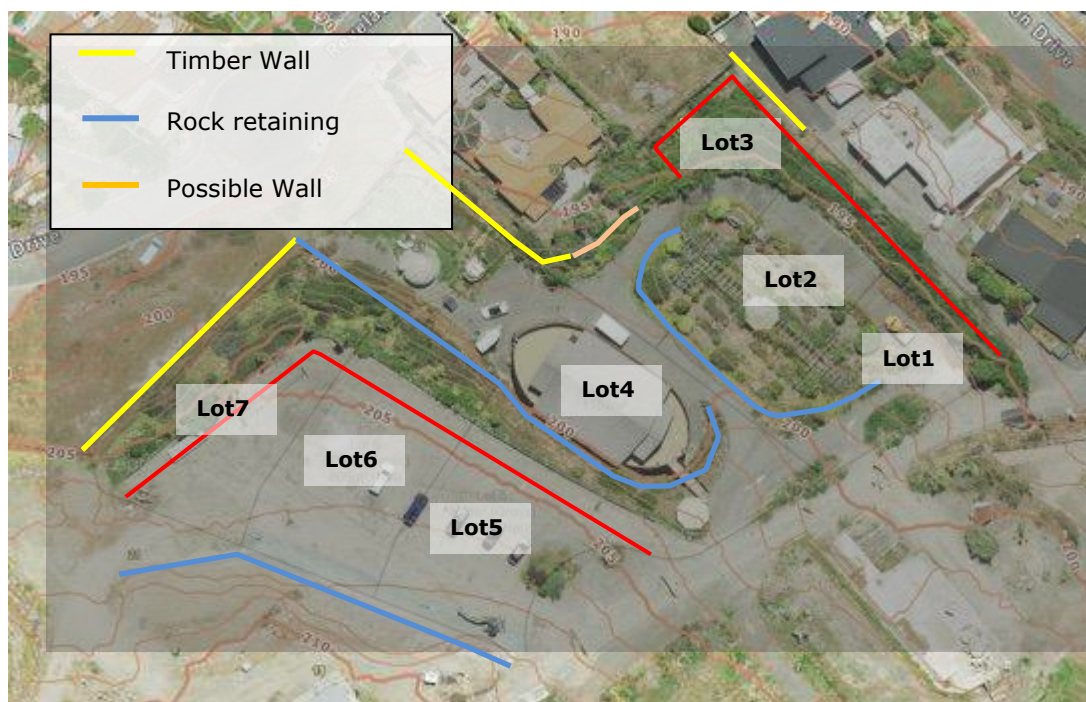
Given the sites performance in terms of slope stability post the Christchurch Earthquake Sequence and with a nearby a motion sensor recording ground displacements of 1.3g post the 22 Feb 2011 earthquake event having no recorded damage, EDC considers the walls on Lot 4 to be at low risk of failure. To prevent loading of these walls, BLL's have been placed on Lots 5 - 7 as discussed in section 7.4.2.

Figure 25: Existing retaining wall structures, with contours. The approximate location of the Building Limitation Line is in red
